Aircraft Accident Report

SILKAIR FLIGHT MI 185

BOEING B737-300

**Investigation of Aircraft Accident
SilkAir Flight MI 185
Boeing B737-300, 9V-TRF
Musi River, Palembang, Indonesia
19 December 1997**

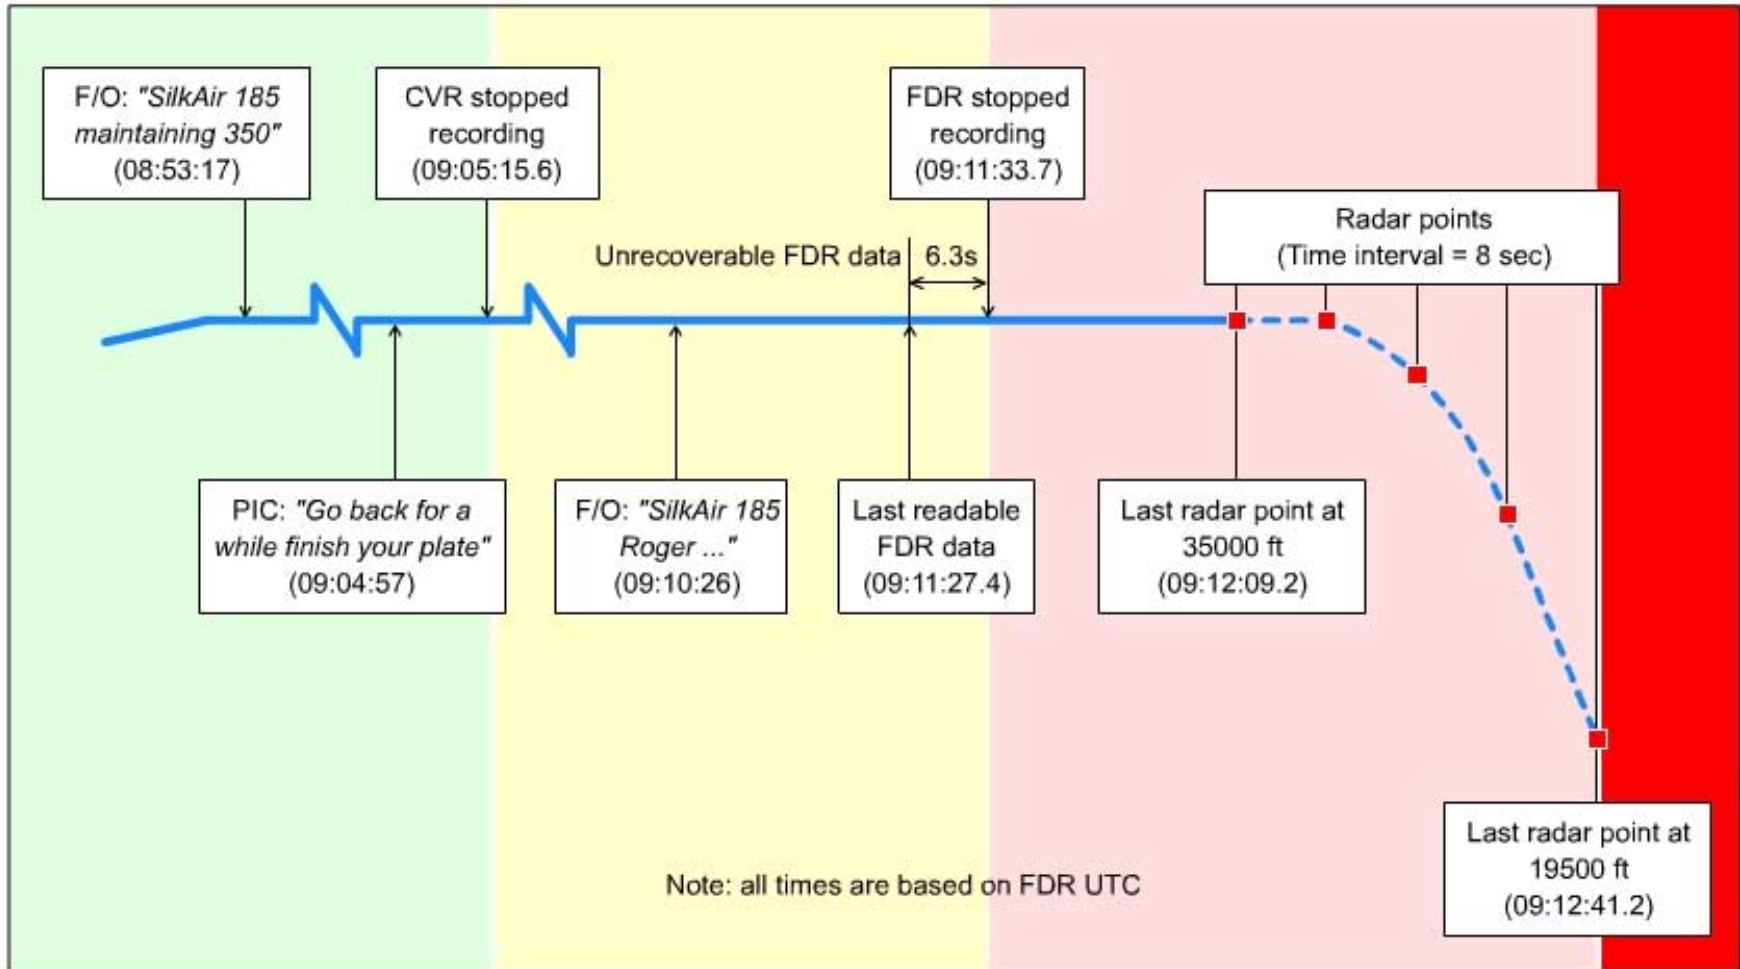
Figure 2 - Sequence of Events

The FDR stopped recording at 09:11:33.7, or 6 minutes and 18.1 seconds after the CVR stoppage, and approximately 35.5 seconds before the aircraft started its descent, see Section 1.11.1 and Figure 2. Data recorded by the FDR indicates that the flight was normal until the FDR stoppage time. It was concluded that until the stoppage of the FDR, there were no indications of unusual disturbance (e.g. atmospheric turbulence, clear air turbulence, or jet stream upsets, etc.) or other events affecting the flight.

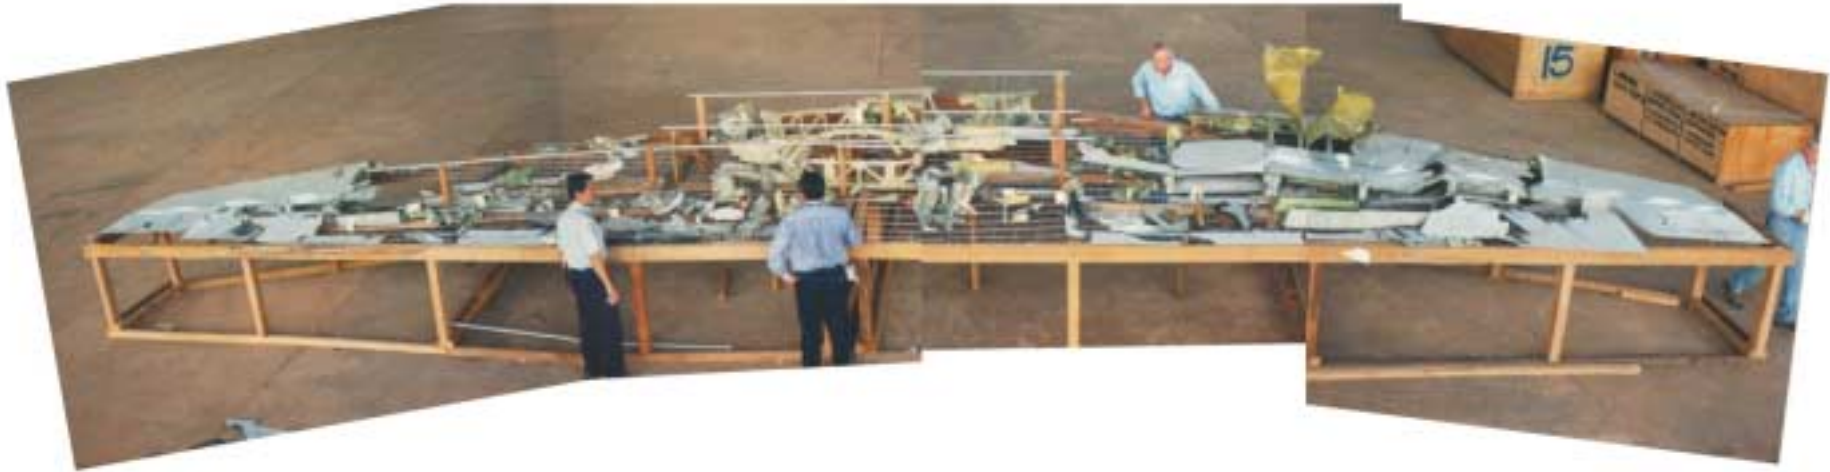
Figure 11 Picture of the reconstructed empennage

The parts of the horizontal stabilizer center section (“Texas Star”) were recovered in the river and were found broken due to impact, see Figure 11. In the recovered parts no evidence was found which could be attributed to fatigue failure.

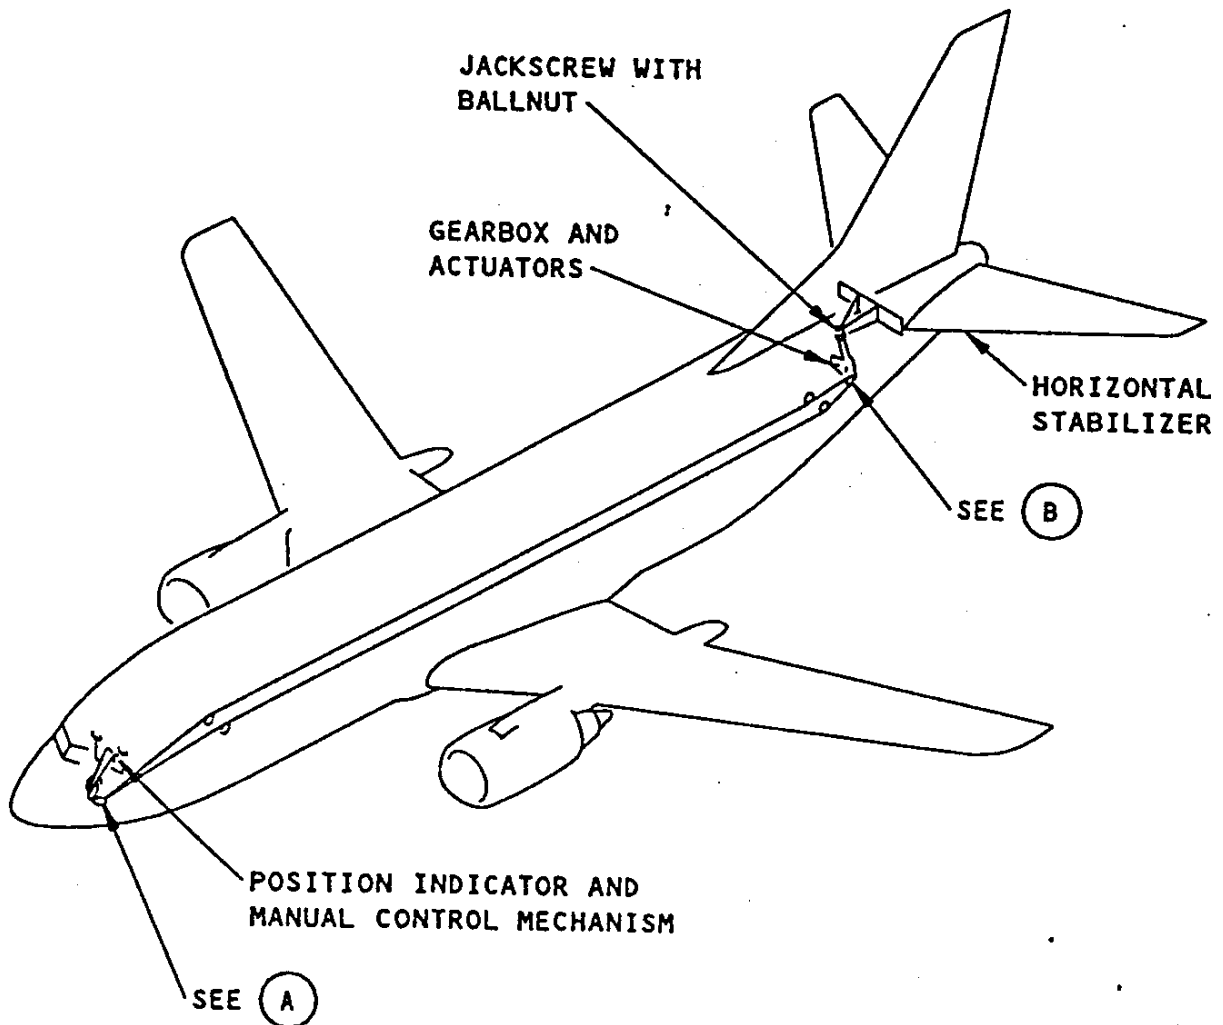
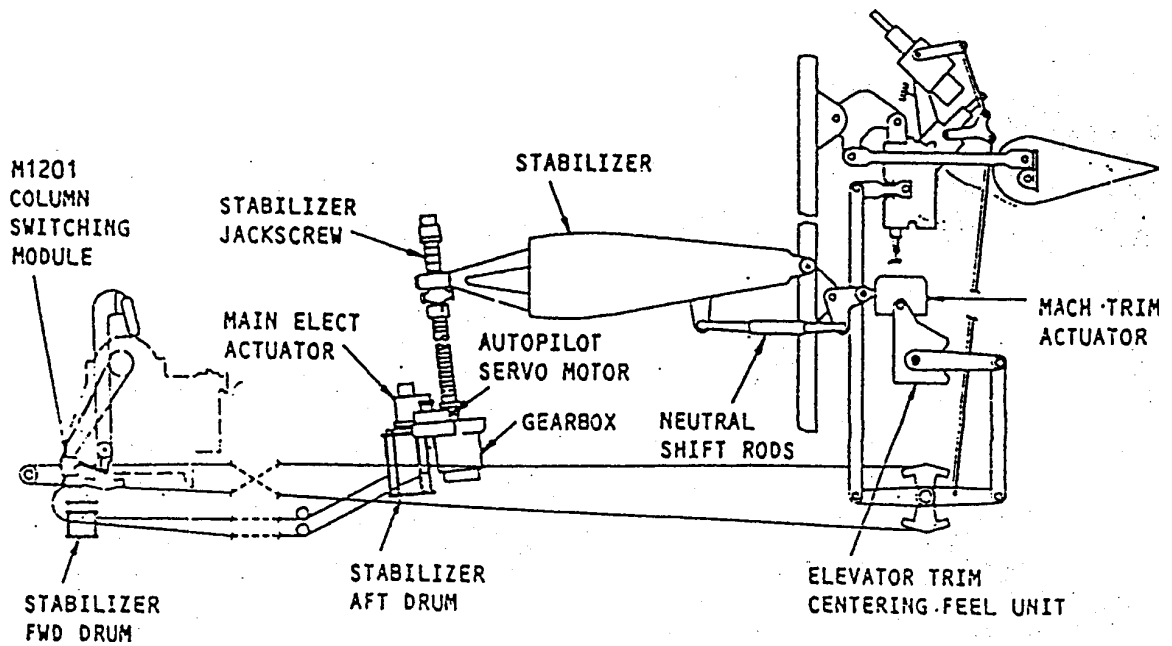
Figure 13 Horizontal Stabilizer Trim

- i) Horizontal stabilizer jackscrew (*Item 23* in Appendix E) – The pictures of the broken jackscrew are shown in Figure 13. The jackscrew ball-nut was found in a horizontal stabilizer trim position of 2.5 units, equivalent to 0.5 degree horizontal stabilizer

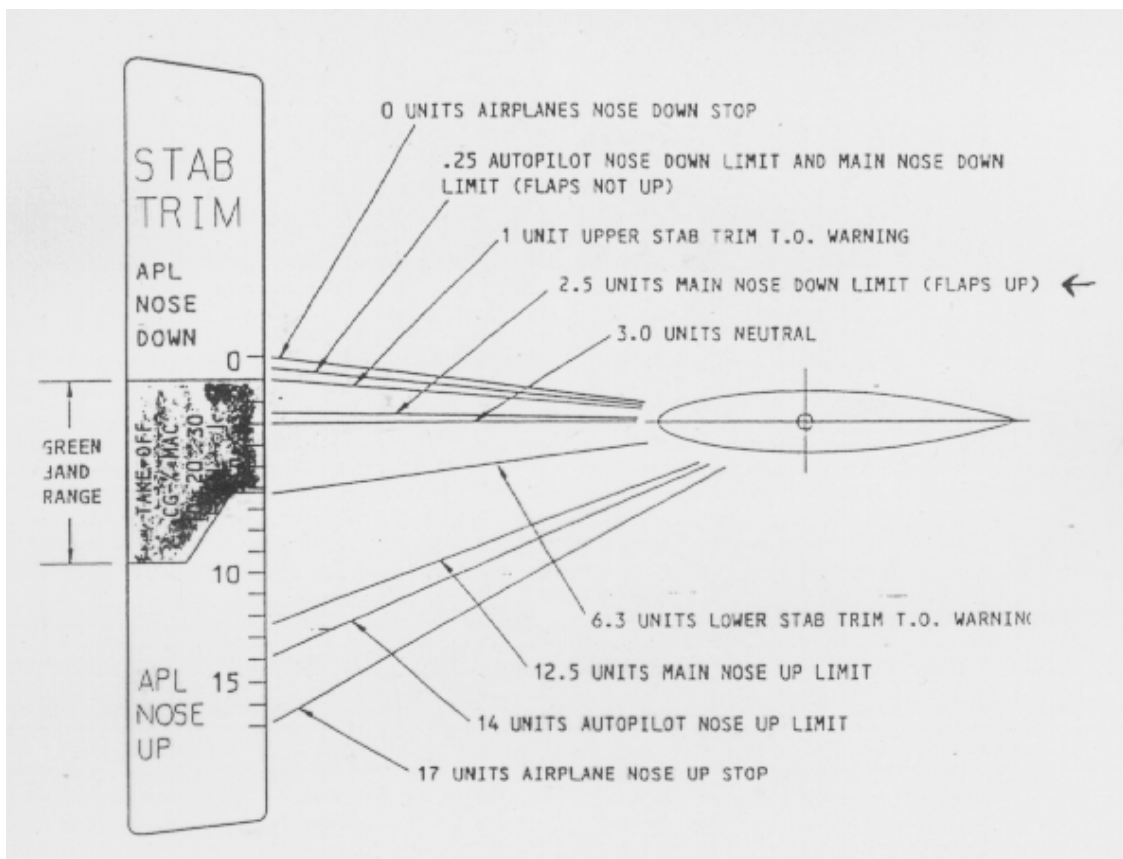
(e) Stabilizer Trim Deflection Scale

⁴ Relation between reading in units and deflection in degrees is given as follows: $x \text{ units} = x \text{ degrees} + 3$. According to the sign convention, deflection of horizontal stabilizer leading edge up means negative, and leading edge down means positive (see Figure 13).

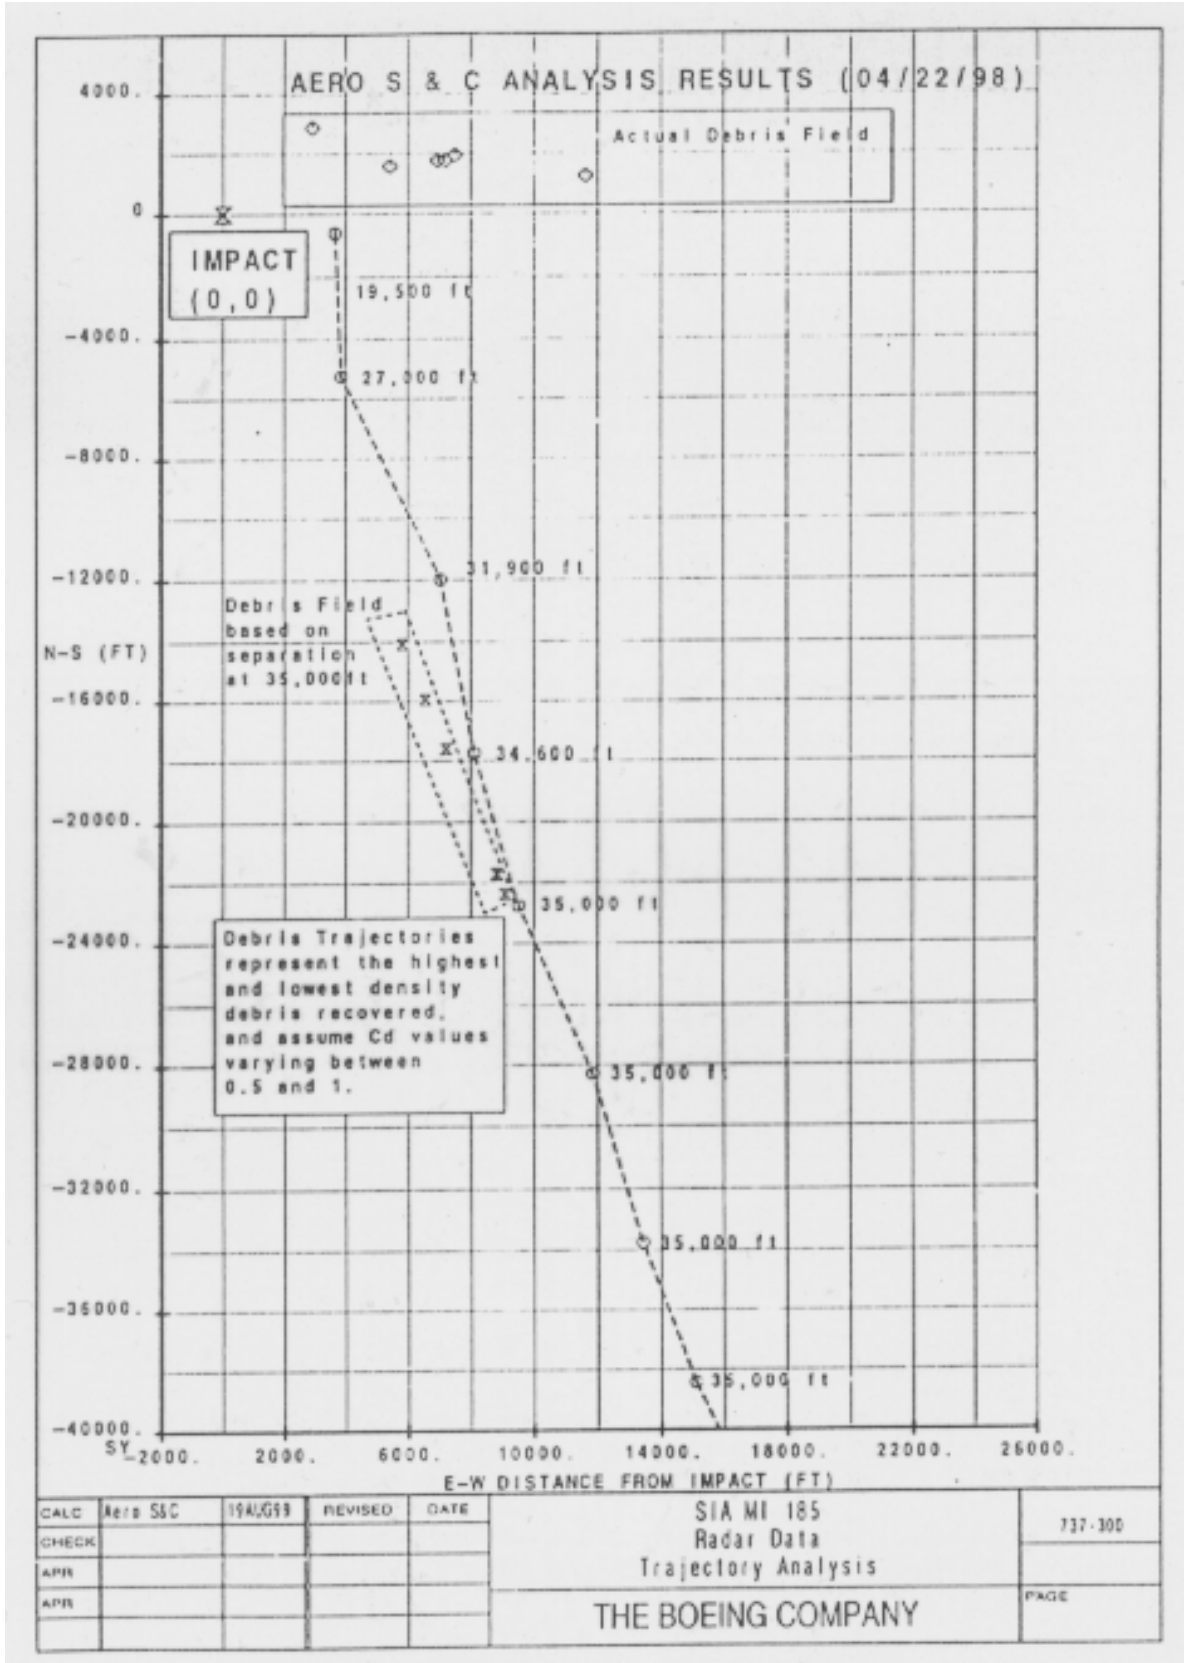
(a) NTSB Results based on separation at 35 000 ft

Both studies, see Figure 14, were based on the theory that the trajectory of a separated object was determined by its initial condition at the time of separation, such as mass, speed, heading, altitude and its aerodynamic characteristics as well as the wind direction.

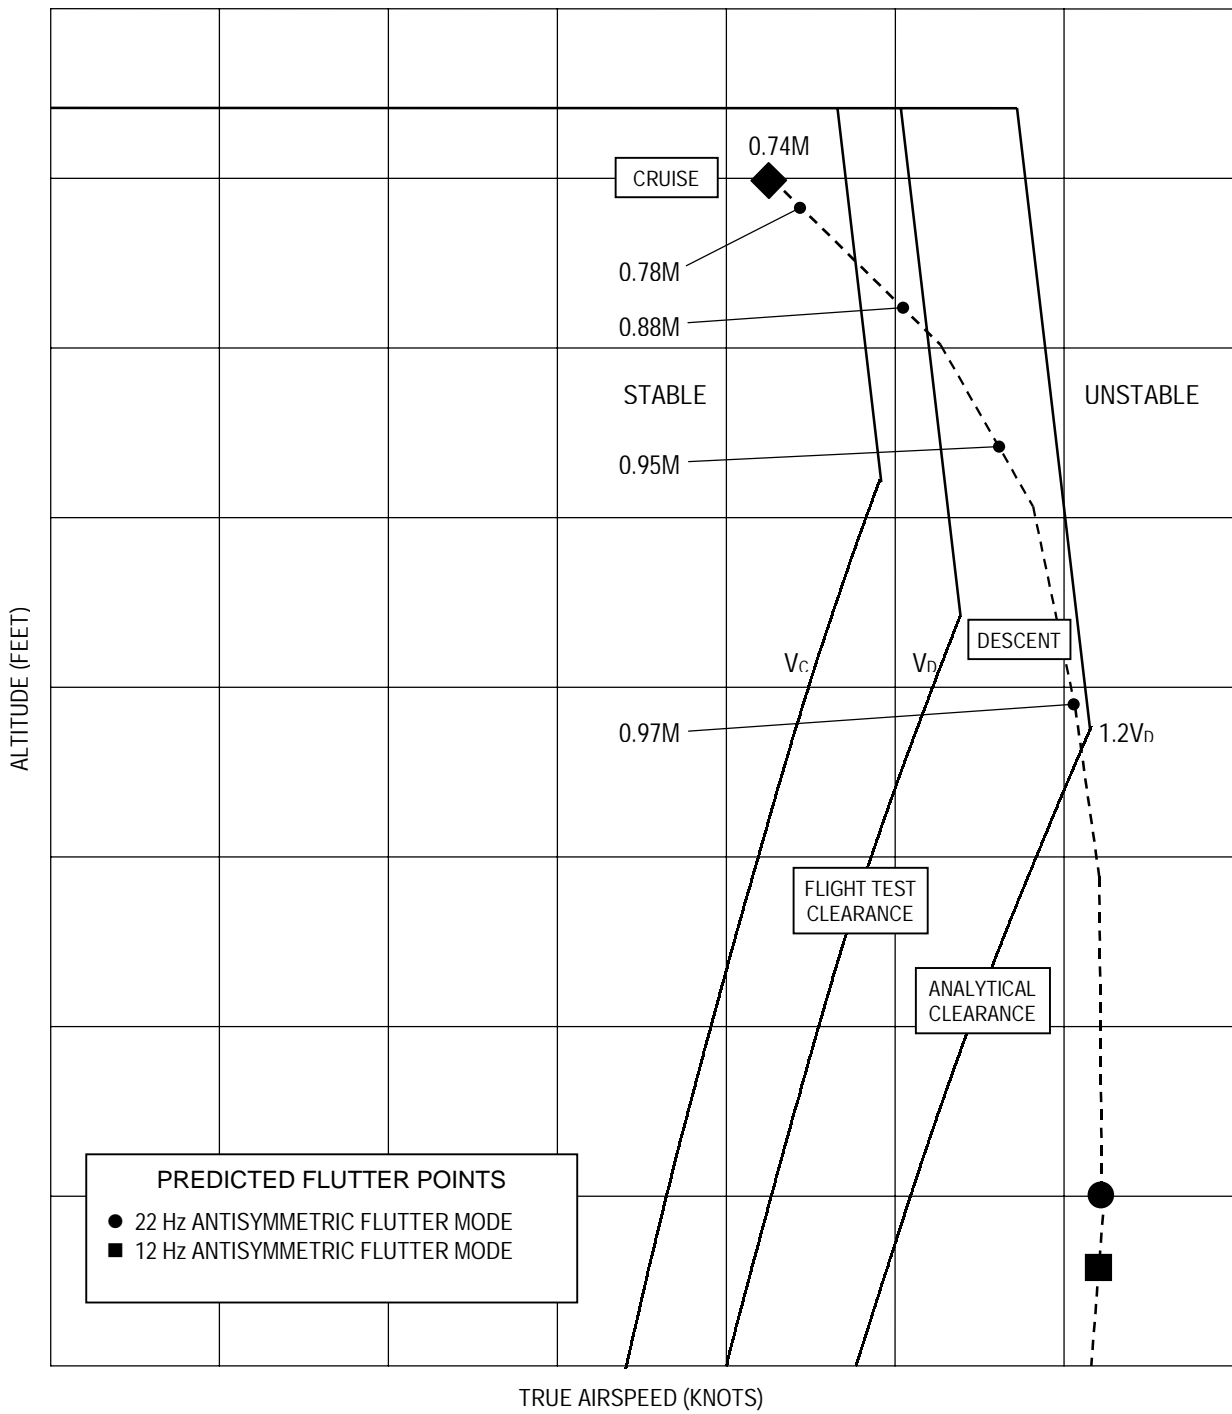
Figure 15 Diagram of Boeing B737 Flutter Flight Envelope

- During descent from 20,000 feet to ground impact
The applied static loads are less than the design ultimate load envelope and do not support separation of the empennage during the final descent below 20,000 feet. The estimated descent speed exceeded the 1.2 dive speed V_d analytical flutter clearance speed at approximately 18,000 feet altitude. An onset of an empennage 22 Hz anti-symmetrical flutter mode was calculated to occur later in the descent at approximately 5,000 feet altitude (570 equivalent airspeed in knots-KEAS). A lower frequency 12 Hz anti-symmetrical flutter mode was calculated to occur at approximately 3,000 feet altitude (600 KEAS), see Figure 15.

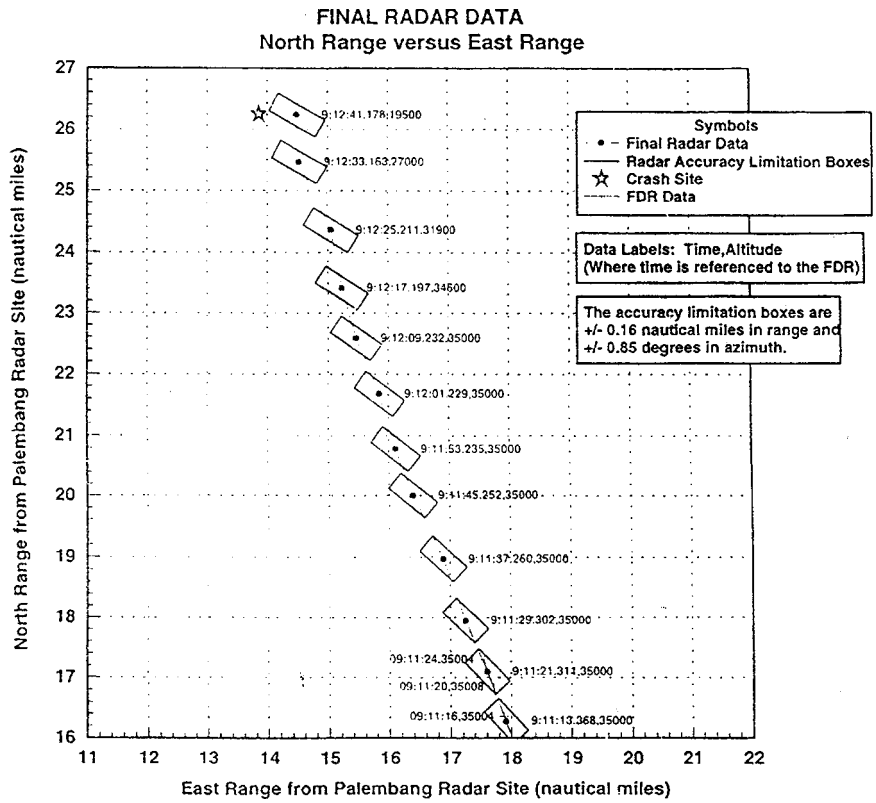
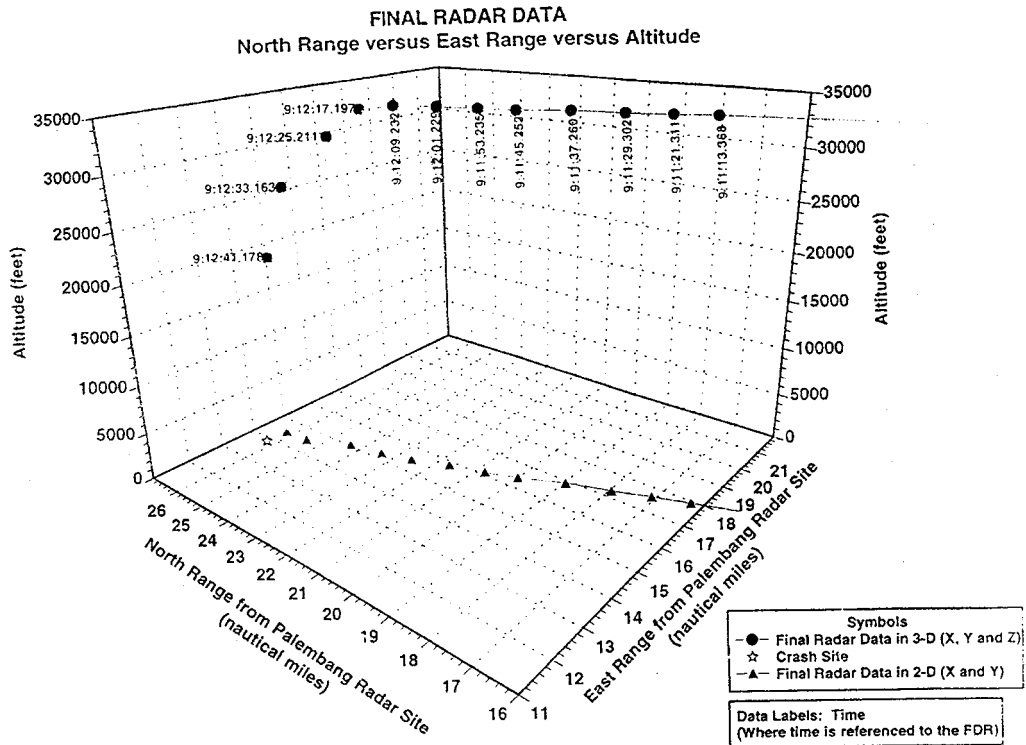
Figure 16 Corrected Radar Data

The radar data and information retrieved from the GUARDIAN system was further examined and corrected, by Boeing as well as NTSB, focusing particularly on the last twelve radar returns. Based on this final radar data, the aircraft flight path and its ground track projection was reconstructed, see [Reference 18] and Figure 16.

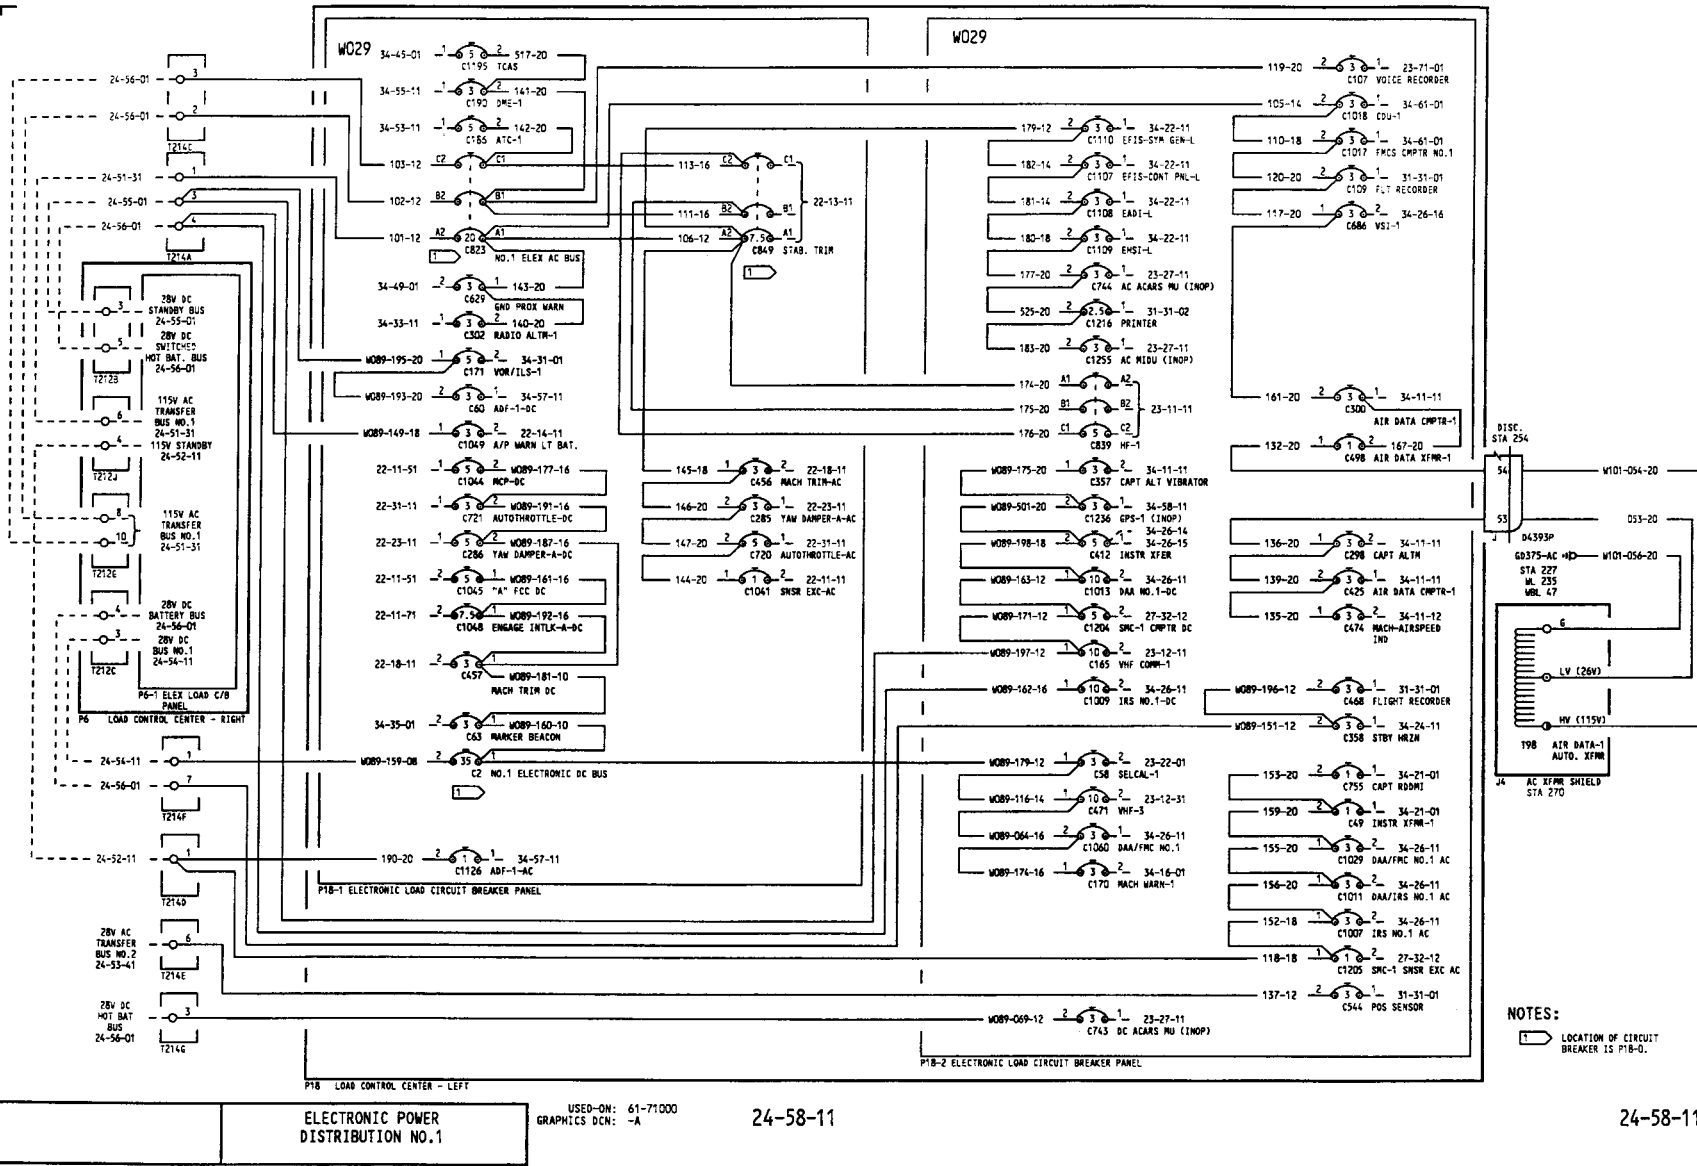
Figure 17 Wiring Diagram 24-58-11

According to the aircraft wiring diagram 24-58-11 (Figure 17) the power to the CVR was from the Electronics Bus 1 (Elex Bus 1). The Elex Bus 1 also supplies power to other systems, such as the FDR, DME-1, TCAS, ATC-1 etc. Parameters of DME-1 and TCAS were recorded in the FDR. Analysis of the FDR recording showed that six minutes after the CVR stopped, the FDR was still recording TCAS and DME-1 parameters. This indicates that the CVR stoppage was not due to power loss at Elex Bus 1.

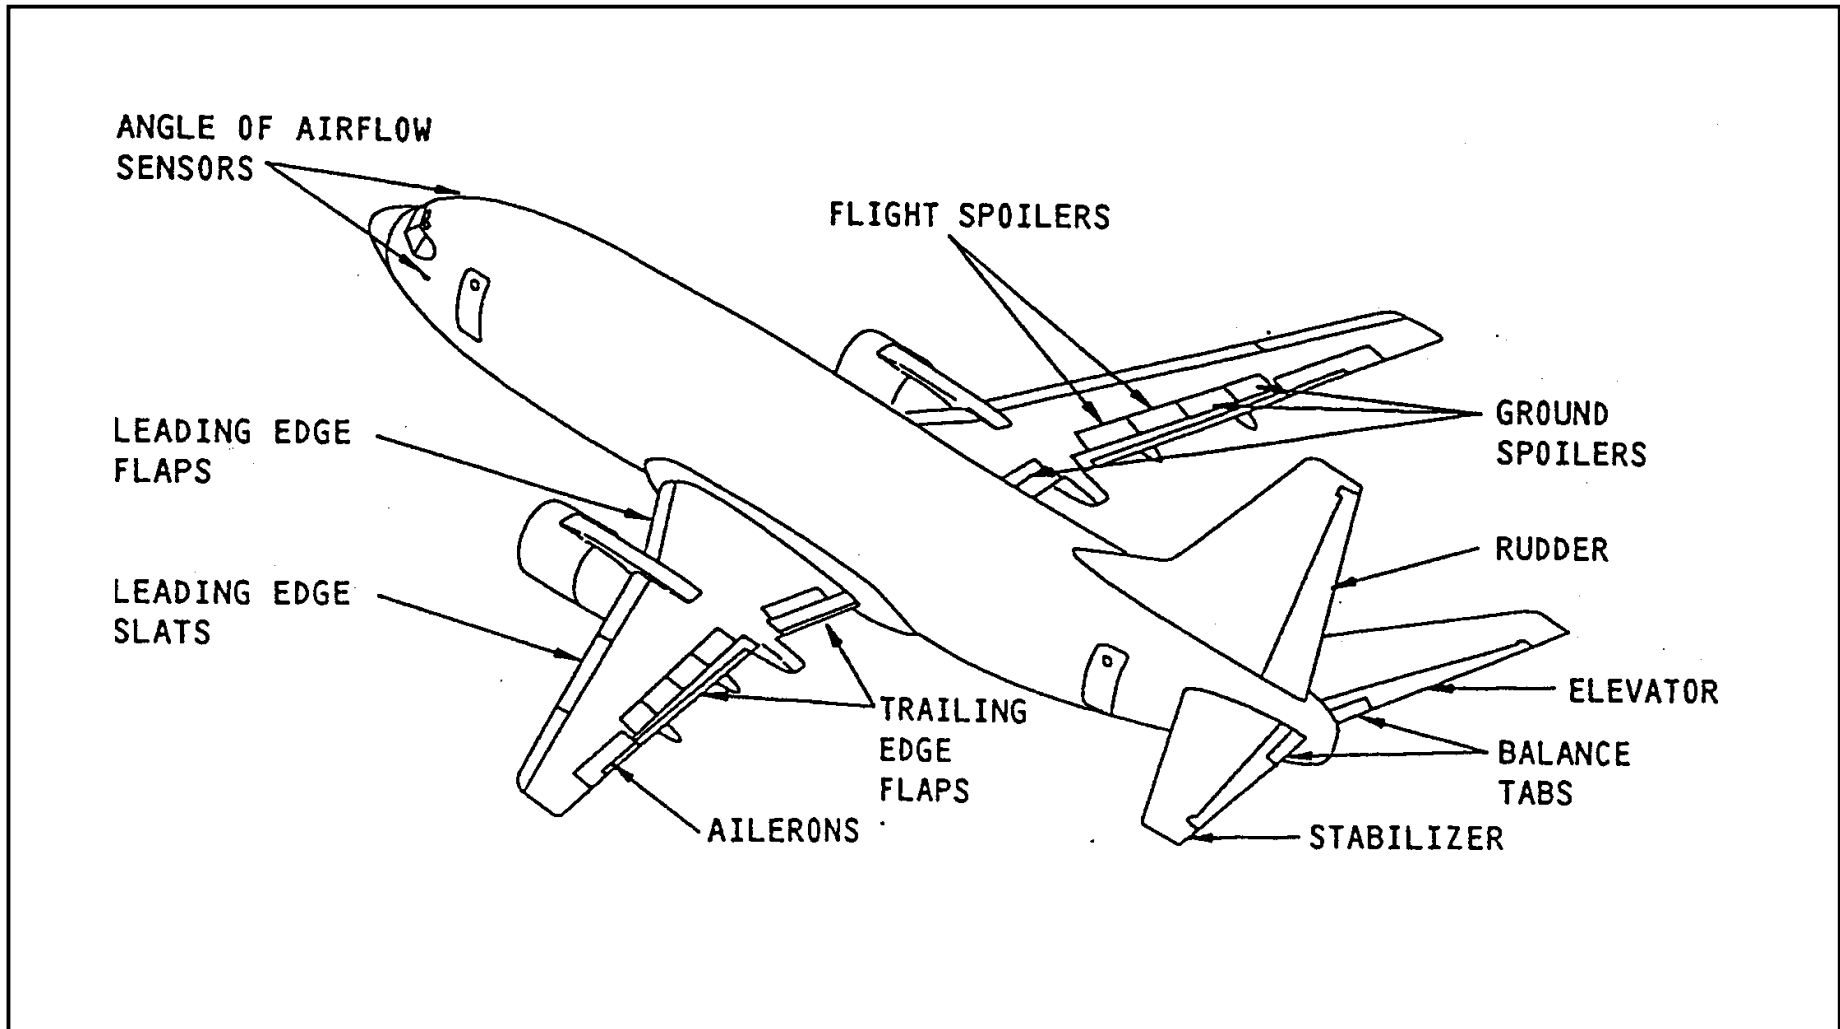
Figure 18 Flight Control Surfaces Location

Flight spoiler actuators – four units per aircraft: (Items 7, 8, 9 & 10 in Appendix E) All four flight spoiler actuators were recovered and examined. The actuators were found to be in the fully retracted position (see Figure 18).
